THESIS

AN INVESTIGATION OF PLASMA - SURFACE
INTERACTIONS ON SELECTED
CONDUCTORS AND INSULATORS

December 1980

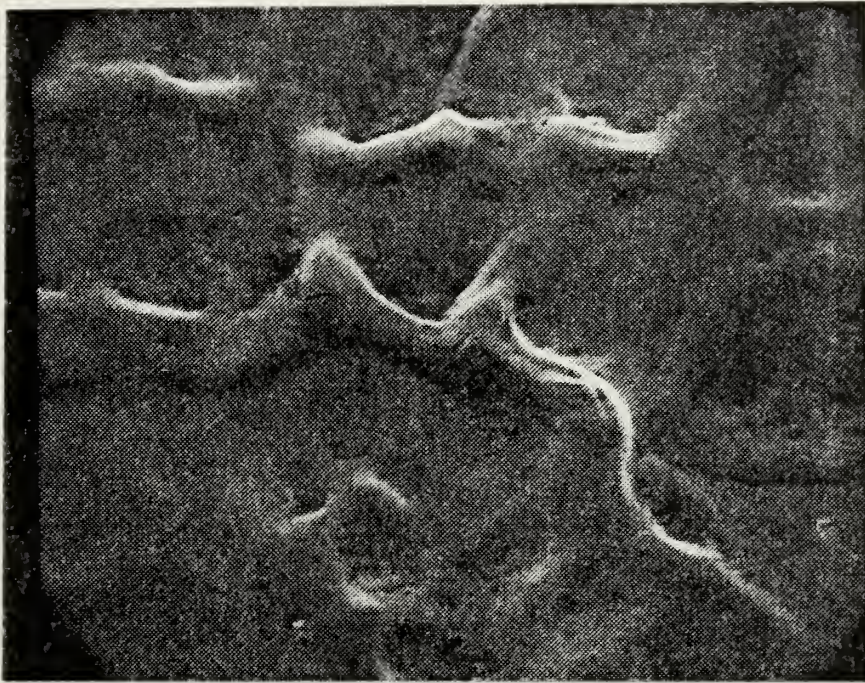
FIGURE 11. VACUUM IRRADIATED STAINLESS STEEL. THIS VIEW IS AN ENLARGEMENT OF CENTER OF FIGURE 10 SHOWING PLASMA DAMAGE AT THE PERIMETER OF THE CENTRAL CRATER. (1000X SEM)

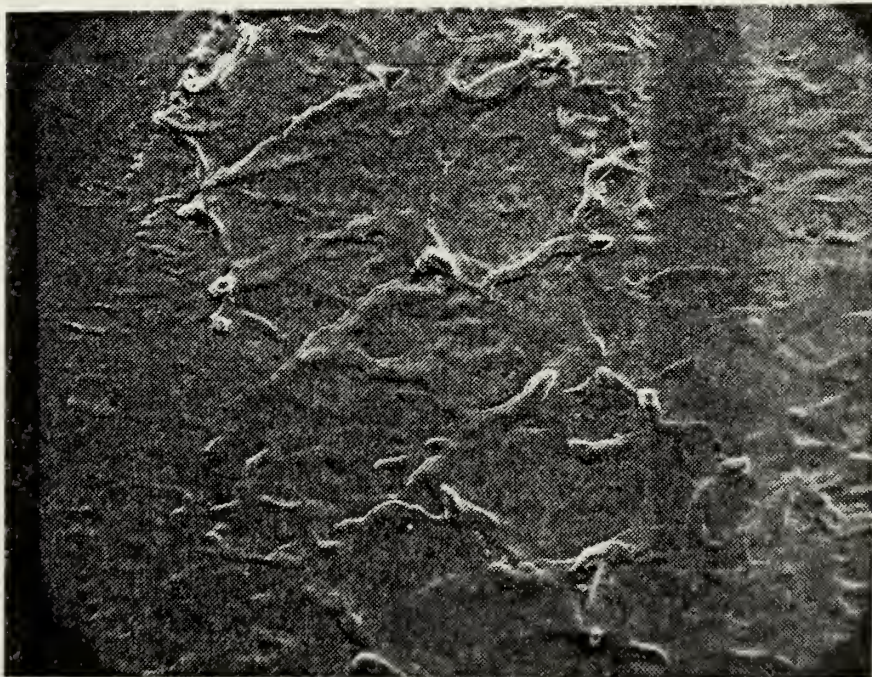
FIGURE 12. VACUUM IRRADIATED STAINLESS STEEL. THIS VIEW SHOWS THE CENTER OF MAIN LASER DAMAGE AREA. NOTE UNIPOLAR ARC CRATERS. (200X SEM)

Figures 12 to 14 are photographs of a laser interaction with a different area of the same sample. Figure 12 was taken near the center of the new damaged area. Figure 13 is a closer view of the bubble-like areas shown in Figure 12. The bubbles are caused by the melting of the metal followed by rapid cooling as molten steel was moving away from the laser damaged center. Figure 14 shows the outer perimeter of the damaged area. The main crater is to the right. There is an abrupt end to the area with large craters. To the left of the photograph several smaller craters can be seen. The size

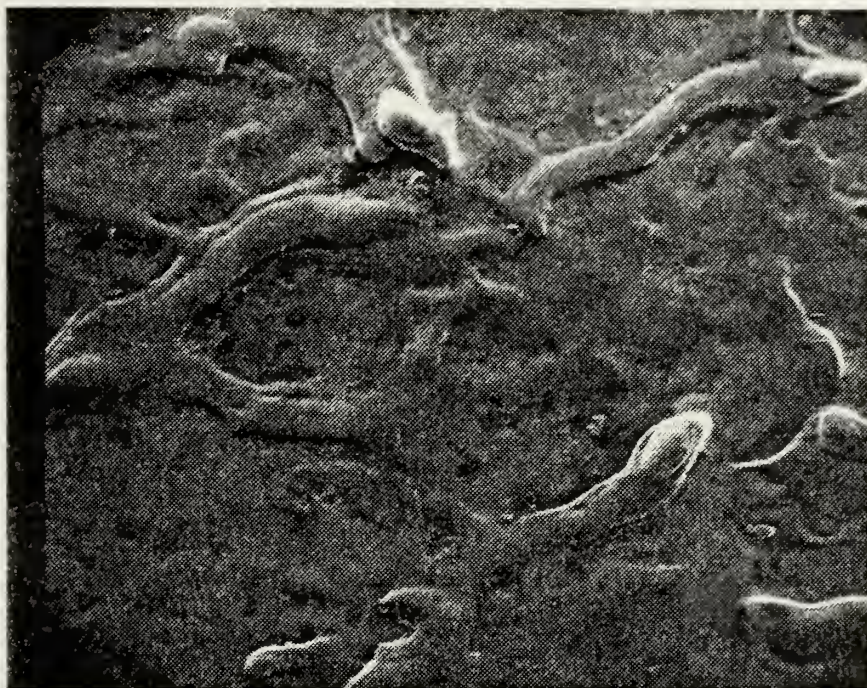
FIGURE 13. VACUUM IRRADIATED STAINLESS STEEL. THIS IS AN ENLARGEMENT OF THE CENTRAL CRATER SHOWING MOLTEN CENTER. (500X SEM)

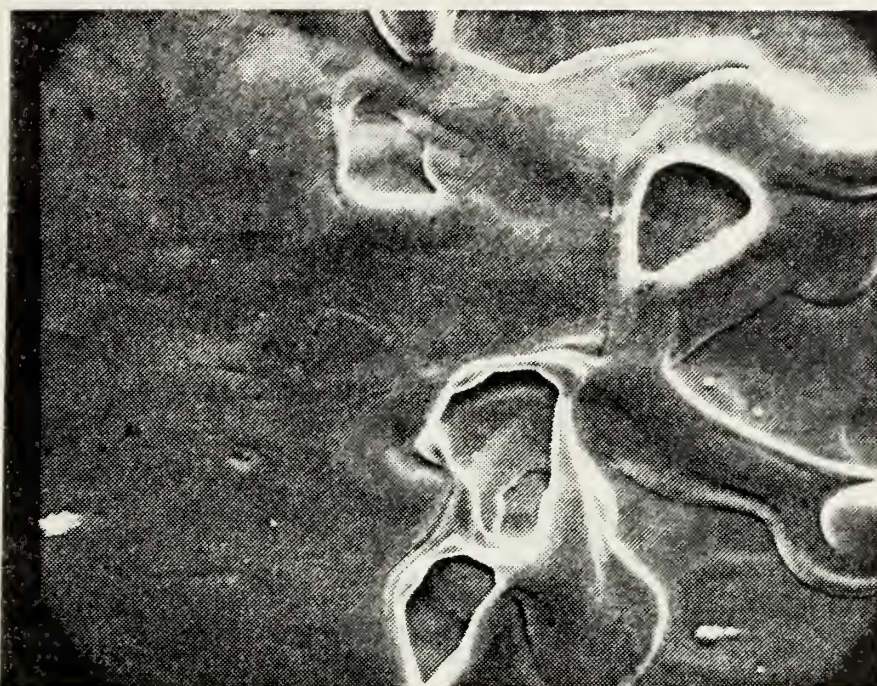
FIGURE 17. AIR IRRADIATED STAINLESS STEEL. THIS VIEW SHOWS THE MOLTEN AREA IN THE CENTRAL CRATER. (1000X SEM)

Figure 18 gives a wider field of view at 500X of the area shown in Figure 17. A few dimples and craters can be seen at the edges of the photograph. The diameter of the

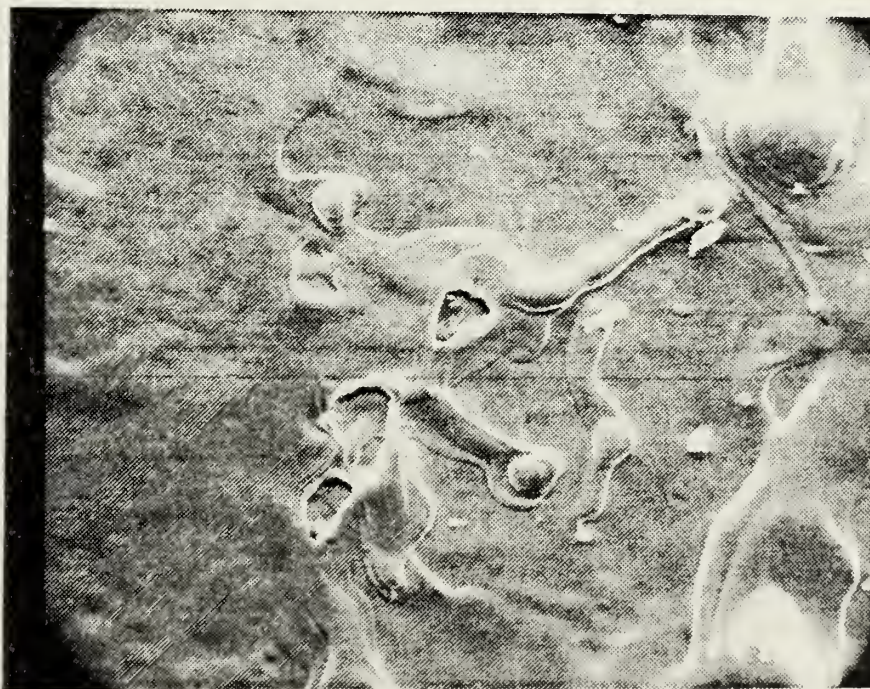
FIGURE 18. WIDE ANGLE VIEW OF AIR IRRADIATED STAINLESS STEEL. THE MAIN CRATER IS TO THE RIGHT. THE ONSET OF PLASMA DAMAGE CAN BE SEEN AT THE LEFT. (500X SEM)

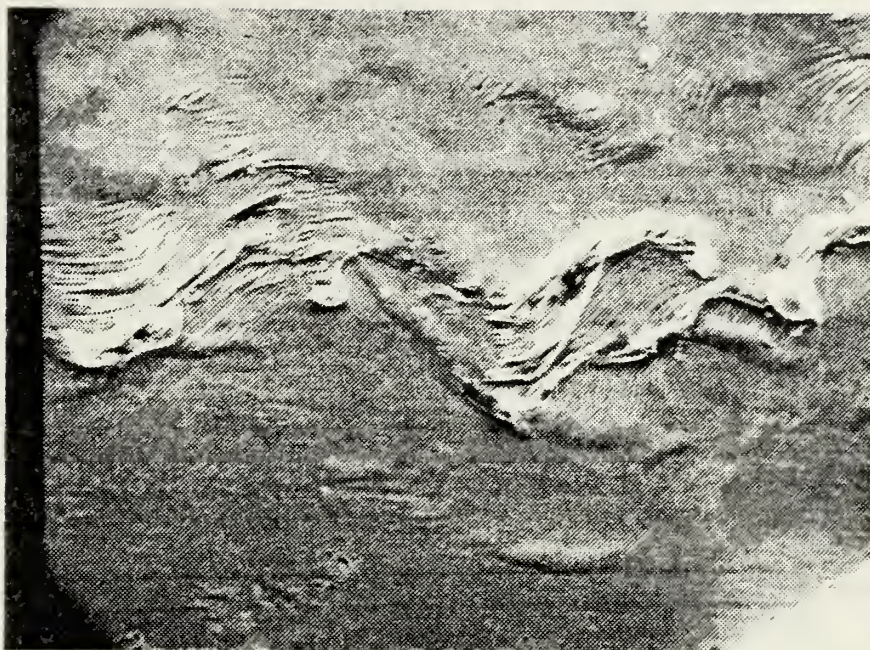
FIGURE 19. AIR IRRADIATED STAINLESS STEEL. THIS IS A VIEW OF THE OUTER PERIMETER OF THE MAIN CRATER AND SHOWS WHERE THERMAL EFFECTS STOPPED. NOTE UNIPOLAR ARCING CRATERS AT THE BOTTOM OF THE PHOTOGRAPH. (500X SEM)

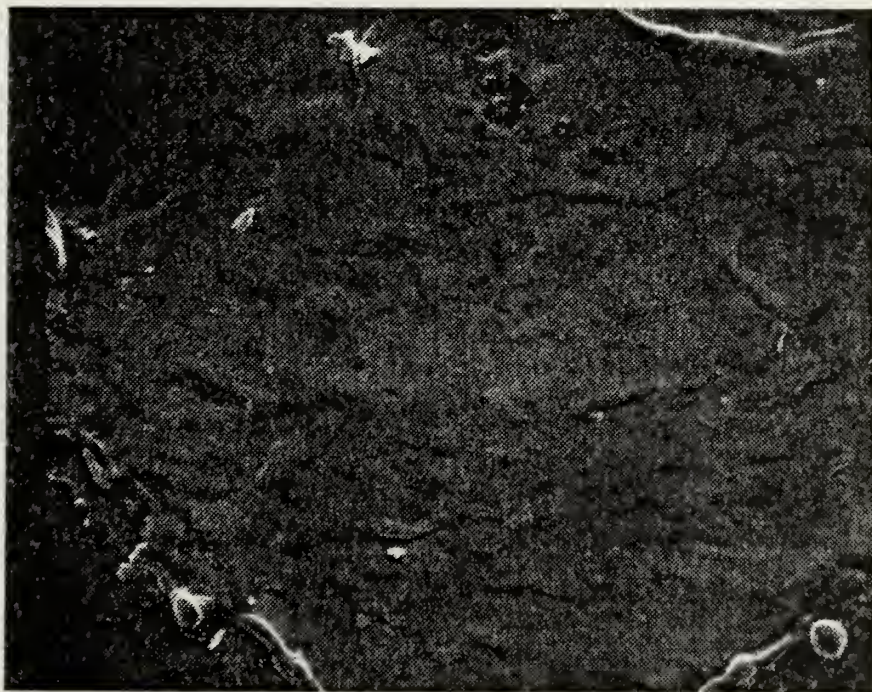
FIGURE 22. NICKEL IRRADIATED IN A VACUUM. PHOTOGRAPH OF CENTER OF MOLTEN CRATER. (500X SEM)

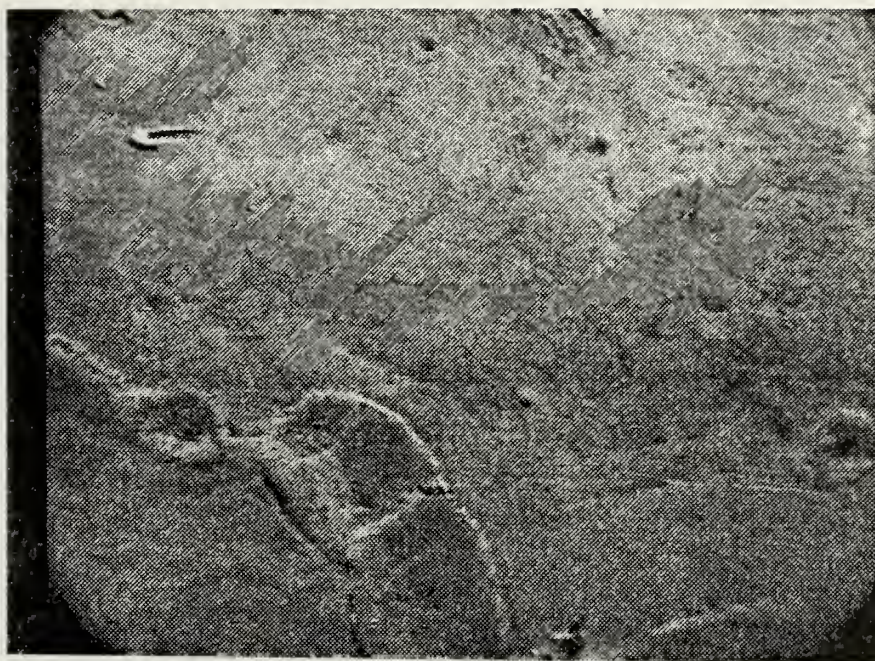
FIGURE 25. NICKEL IRRADIATED IN A VACUUM SHOWING OUTER PERIMETER OF MAIN CRATER. (500X SEM)

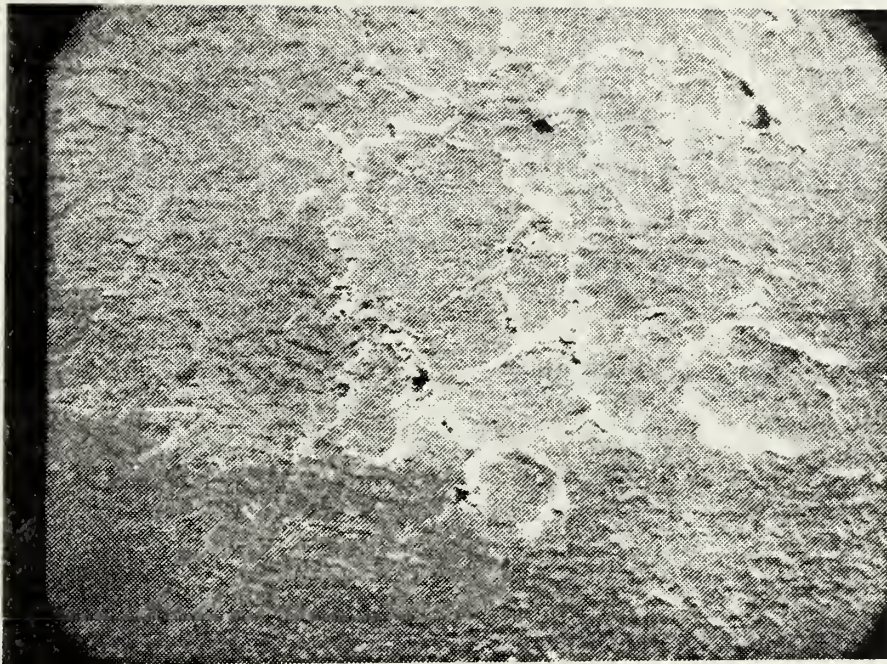
FIGURE 27. NICKEL IRRADIATED IN AIR SHOWING PRIMARY DAMAGE AREA. (100X SEM)

The specimen that was used above was cut in half. The undamaged half of the specimen was then irradiated in air at atmospheric pressure. Figures 26 and 27 are 100X photographs of the center of the damage area taken by the optical microscope and the SEM, respectively. The damaged area was 1.6 mm in diameter and 45 μ m deep. Figure 27 shows thermal damage around the center of the damaged area. To the left of the damage center, evidence of melting is obvious. At a higher magnification of 200X in Figure 28, there is no evidence of cratering caused by unipolar arcing.

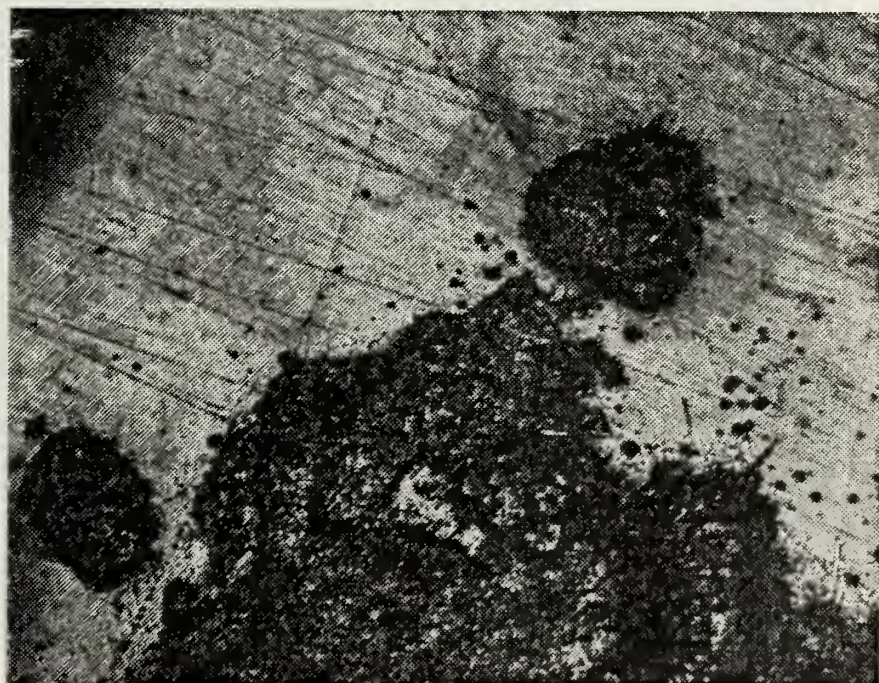
FIGURE 30. COPPER IRRADIATED IN A VACUUM SHOWING DAMAGE AT PERIMETER OF THE MAIN CRATER. (200X OPTICAL MICROSCOPE)

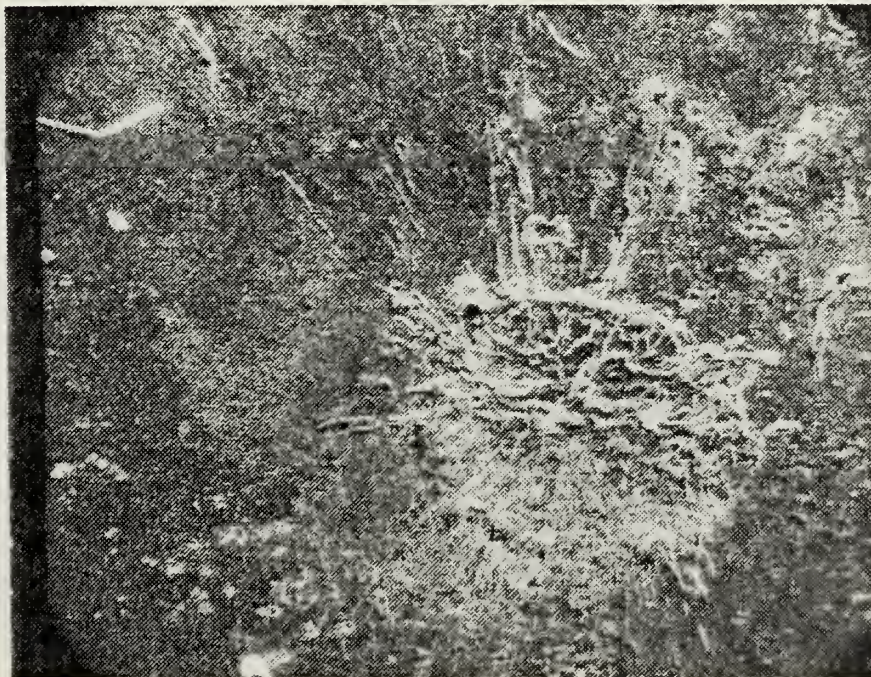
FIGURE 36. COPPER IRRADIATED IN AIR. PRIMARY DAMAGE AREA. (200X SEM)

Comparing Figures 31 and 36 show that the copper experienced a much more violent reaction to the laser pulse when it was irradiated in a vacuum than at atmospheric pressure. The size and density of the unipolar arcing craters is much greater in the vacuum than at atmospheric pressure. In Figure 33 (vacuum) the unipolar craters are 12.5 μm in diameter and their density is about 2000 per cm^2 . In Figures 37 and 38 (atmospheric pressure) the unipolar craters are 8-10 μm in diameter and their density is still about 2000 cm^2 .

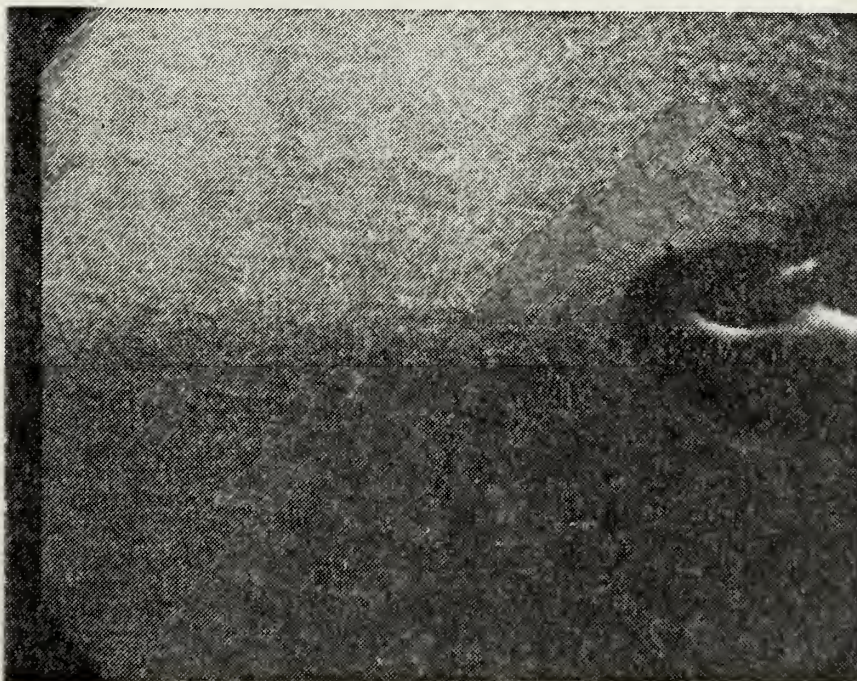
FIGURE 53. TITANIUM FOIL. LASER HOLE IS TO THE RIGHT. (200X SEM)

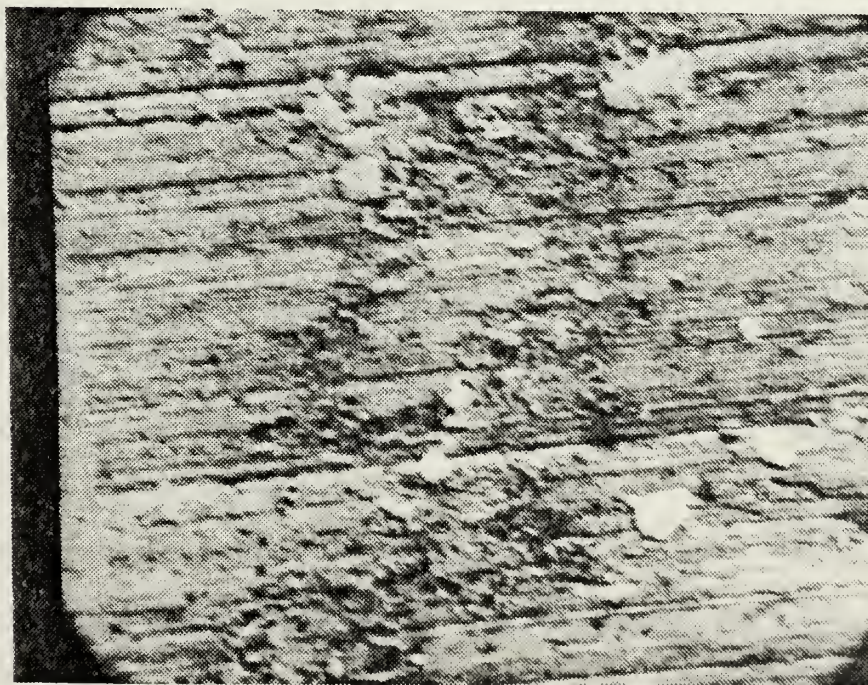
FIGURE 57. TUNGSTEN CARBIDE COATED WITH TITANIUM SHOWING CRATERING THAT ERODED Ti FROM THE SURFACE. (500X SEM)

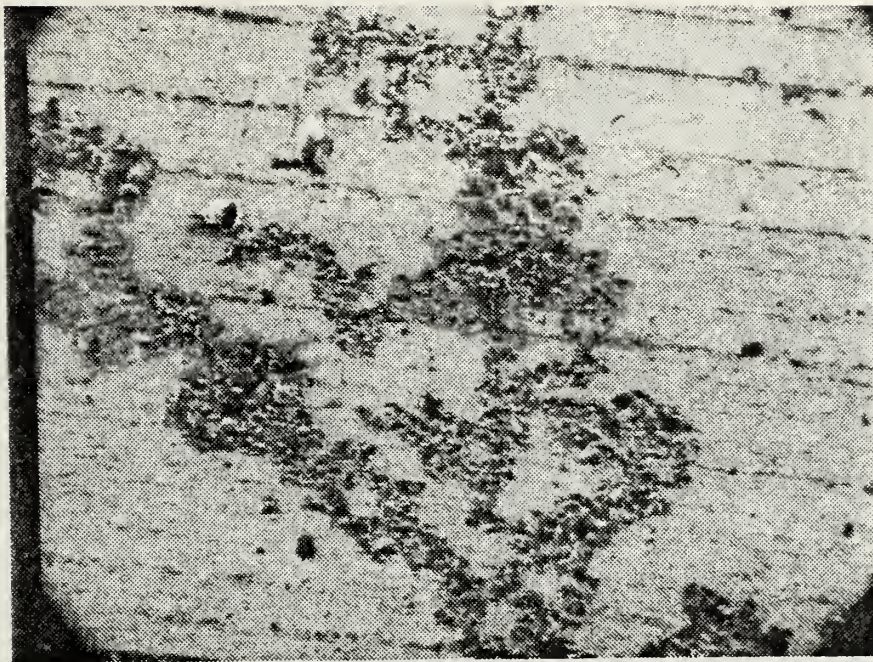
FIGURE 58. STAINLESS STEEL COATED WITH TITANIUM SHOWING CRATERING THAT ERODED Ti FROM THE SURFACE. (200X SEM)

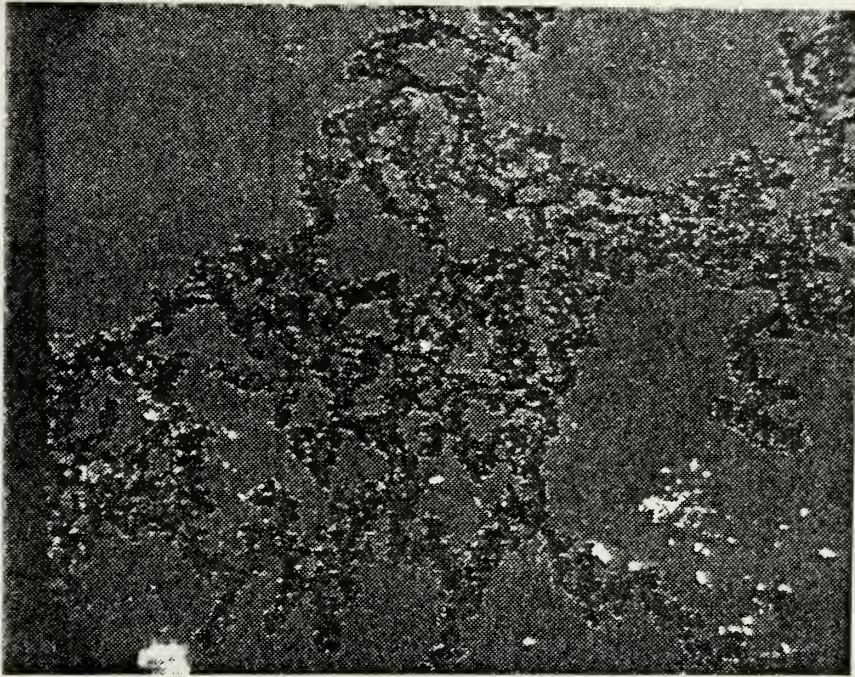
FIGURE 63. GLASS COATED WITH Ti. DISTINCT BRANCHED ARC TRACK ACROSS THE Ti COATING. (50X SEM)

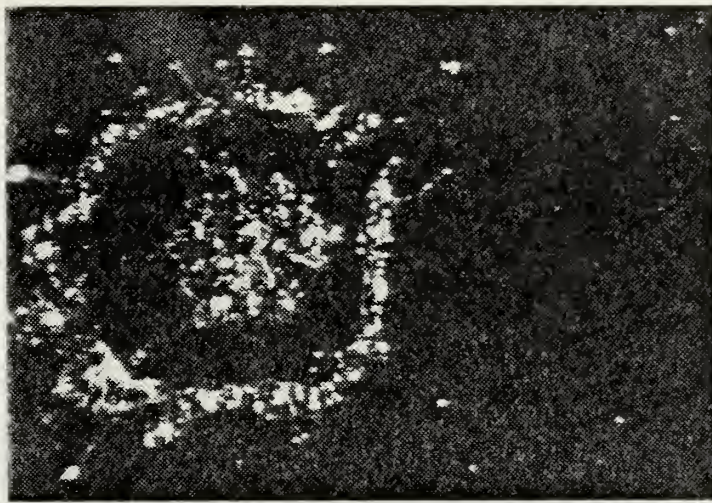
FIGURE 71. DAMAGED AREA ON CO₂ LASER WINDOW. (40X OPTICAL MICROSCOPE)
